JAWA Motorcyclist

250 Travel 1500k Service

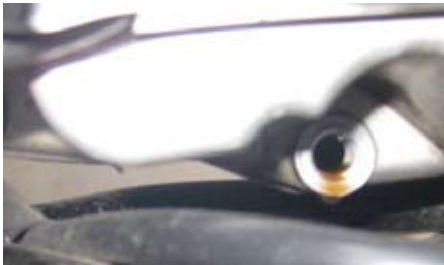
I must say I was looking forward to seeing what made the bike tick. Pat helped greatly by his sterling work translating the Jawa Handbook into English. So with the engine warm after purchasing oil and a new set of feeler gauges, I immediately drained the old oil. As there is only 1000k on this oil I will not be short of chain oil for quiet a while. As the bike pissed into the bucket I took off the seat and tank. The tank was not full, I turned off the fuel tap, disconnected the carb. A 10mm spanner loosened the two bungs

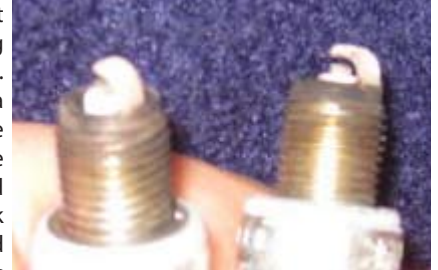
which pull out. Then slide the tank back towards the rear of the bike. An allen key took off the two side covers to reveal the plugs. Nicely protected from the elements. The plugs looked fine although one was a slightly lighter colour (*think I found out why later*). Of the 4 bolts that hold the head 2 were loose. I removed them all and the two top allen key screws. Everything was nicely covered in oil and very easy to get at. With the two screws removed from the side casing I rotated the crank anticlockwise. You can not see when the cams are up so with a finger on the top of the tappet I rotated the crank till I had flywheel mark lined up and the tappet at its highest point. I then measured the gap. Not having the correct settings I done this on all valves and noted that nothing matched (*might explain the plug colour, or else its the carbs*). The largest inlet

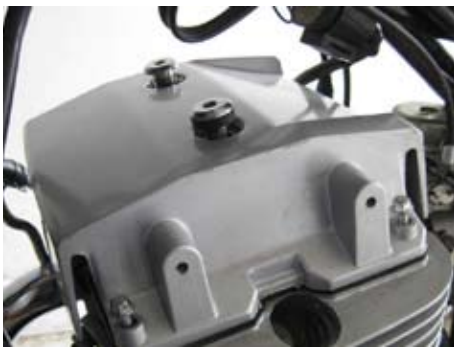
opening was on the left hand pot and it was between .05 and 0.1. That is .05 passed through and .1 did not. The exhaust valve were nearly shut completely. The right hand intake was .04. Time for an executive decision. On my last bike an ER500 the inlet was between .15 and .18 the exhaust was between .18 and .23. This engine is half the size so I decided to match the two inlets to .05 and 0.1. This was not a huge adjustment and as the bike had been running well I felt it was safe. The exhaust should be a larger gap then the inlet. But as this was a more substantial change I matched them. So I set all the tappets

Jawa Ireland have gotten back to me and the correct tappet settings for both inlet and exhaust are .007. So my guess was good at .005 and .01. Lifan are also in contact with me trying to sort me out. The Silver Lady is now tuned up and ready for the road.

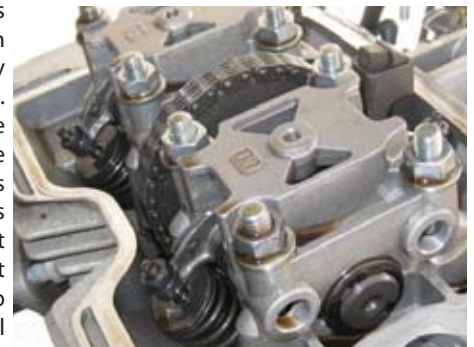
so .005 passed through easily and 0.01 would not.

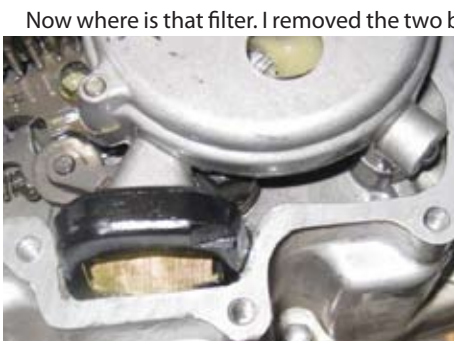
Now where is that filter. I removed the two bolts at the front of the engine hoping that they would reveal something but no. So it was off with the clutch cover. It came off easily after I took off the rear brake pedal. And there it is, just below the pump in a small plastic holder. It look primitive enough but when I washed it in petrol I was surprised how much metal was left in the petrol afterwards. There was no gasket on the clutch cover but I put some instant gasket on it to prevent leaks and reassembled everything. The air filter is foam and seem fine so I just put some oil on it.

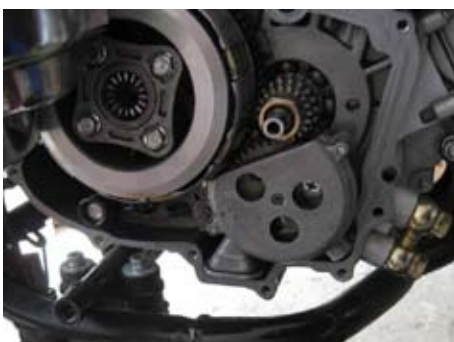
A nuts and bolts check after, nothing was found to be astray.

The bike is very easy to work on, you do not need to be an acrobat to get at anything. I have been in touch with the Jawa company, Lifan the engine suppliers and Paval in Jawa Ireland, to try find the correct tappet settings.
